Metallurgical Evaluation & Failure Analysis

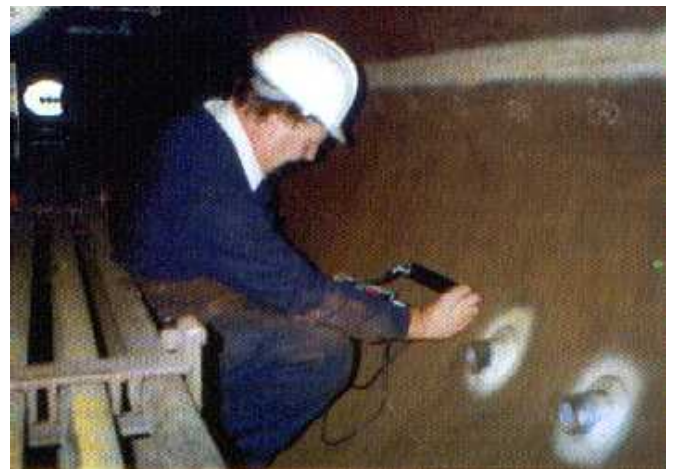
On site inspection of a steam drum

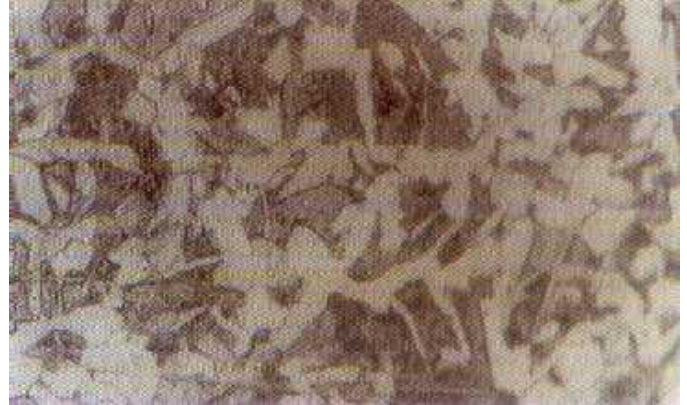
FIGURE 1
Replica of a steam drum steel subjected to overheating 200x

FIGURE 1 shows a replica taken from a steam drum heated to over 650°C and viewed at 200x magnification. On site examination of the vessel's microstructure enabled JOHN THOMPSON Engineers to make an accurate assessment of the damage sustained by the material resulting in huge cost savings to the client.

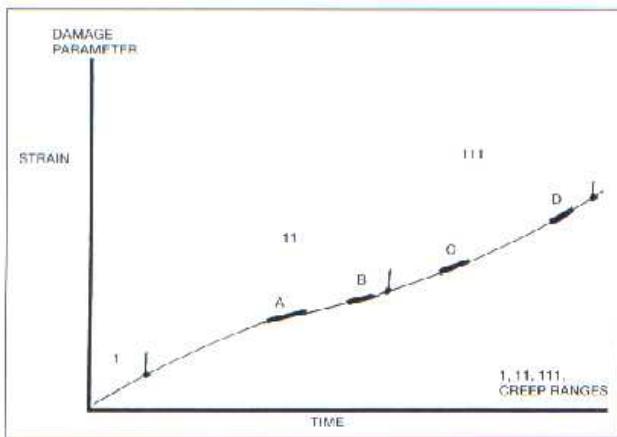
FIGURE 2
Typical creep graph for boiler steel

Using these and other analytical techniques, JOHN THOMPSON engineers can establish the metallurgical condition of materials and relate this to life cycle data such as creep graphs etc. (FIGURE 2)

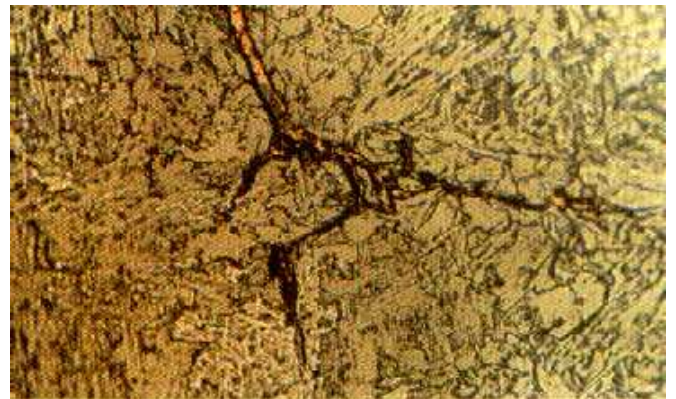
Failed boiler tubing showing copper intrusion
